Ham Hum

March 2018

The official newsletter of
The Hamilton Amateur Radio Club (Inc.)
Branch 12 of NZART - ZL1UX
Active in Hamilton since 1923

VK3RLP Repeater Repairs

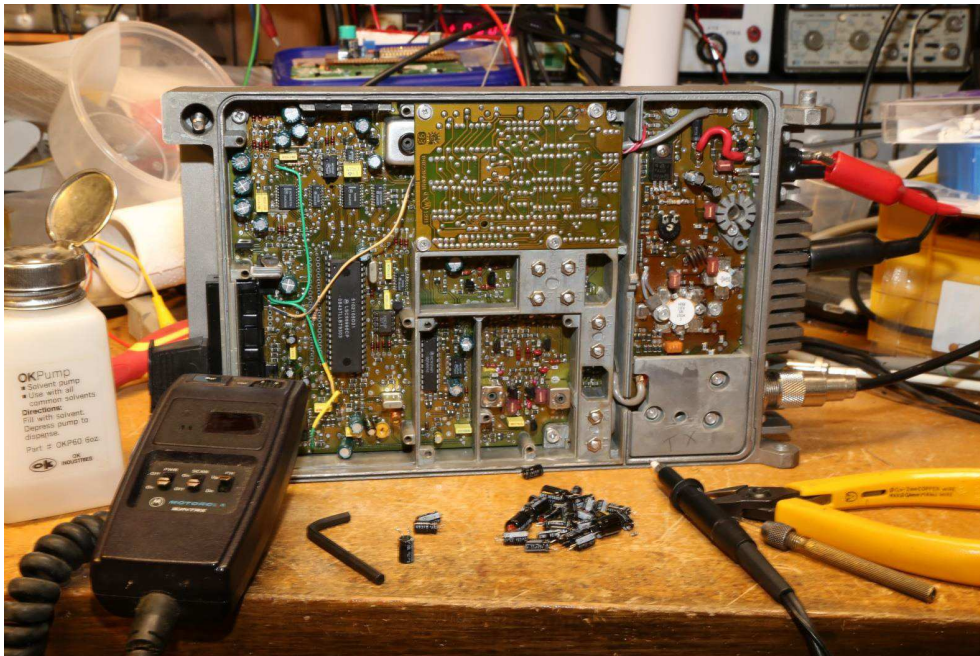
On my bench (the opening photo) the radio behaved identically to what was happening at the club rooms – this was good, as it indicated I had the faulty bit, and the fault was not back in the repeater controller, or power supply.

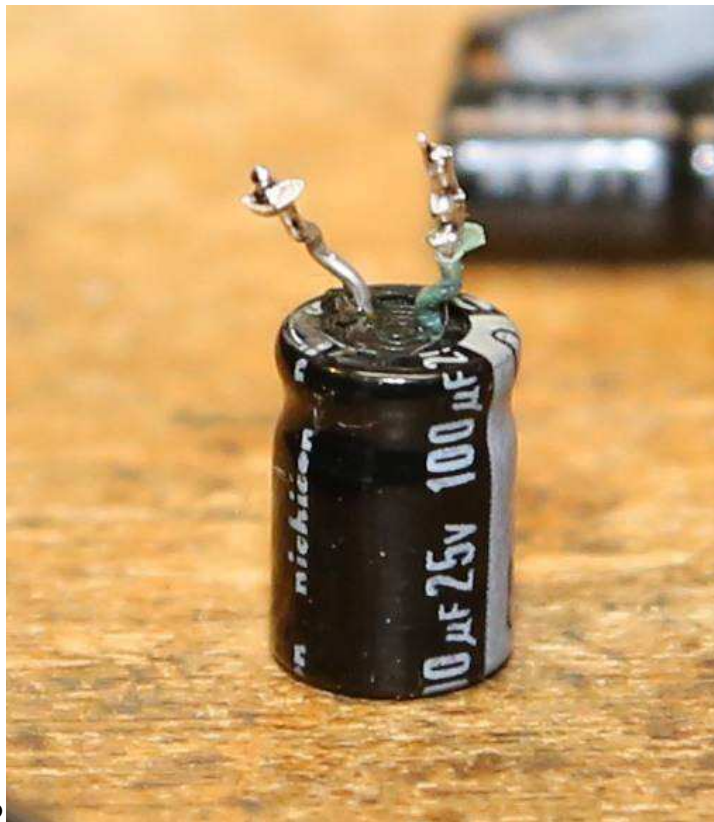
This capacitor is one of the worst, it looks like is has a lime green sleeve on the negative leg, No that is leaking electrolyte and corrosion

The black gunk on the positive lead also had me worried.
